Safety Alert

SA267.R0

Risk of asbestos exposure from centrifugal brake in Avanti service lifts equipped with M508 hoists.

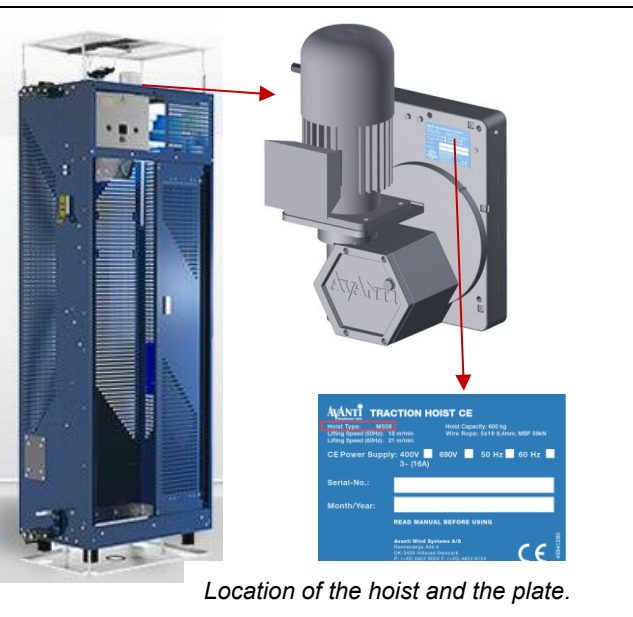
The hoist type is indicated on the identification plate affixed to the motor. When inside the lift, the identification plate is located to the upper right. For easier reading, use your mobile phone to take a photo of the number.

Location of the hoist and the plate.

If maintenance or troubleshooting is required on M508 hoists in Avanti service lifts, do NOT separate the motor and gearbox. If required, the entire traction hoist assembly must be exchanged as one unit.

At all sites the motor and gearbox must remain assembled as a single sealed unit during removal and while in quarantine. They must not be disassembled at any point. The replaced unit must remain in quarantine locally until further notice.

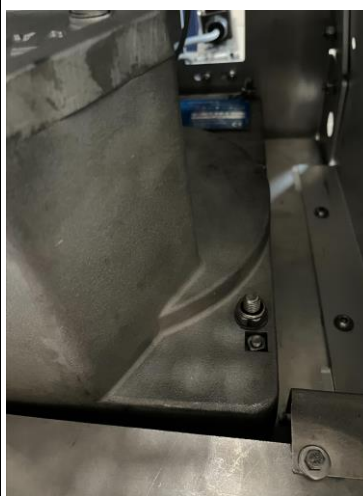
Name plate seen from inside the lift (located to the upper right).
